AIRCRAFT ACCIDENT REPORT

CRASH DURING LANDING
FEDERAL EXPRESS, INC.
MCDONNELL DOUGLAS MD-11, N611FE
NEWARK INTERNATIONAL AIRPORT
NEWARK, NEW JERSEY
JULY 31, 1997

NTSB/AAR-00/02

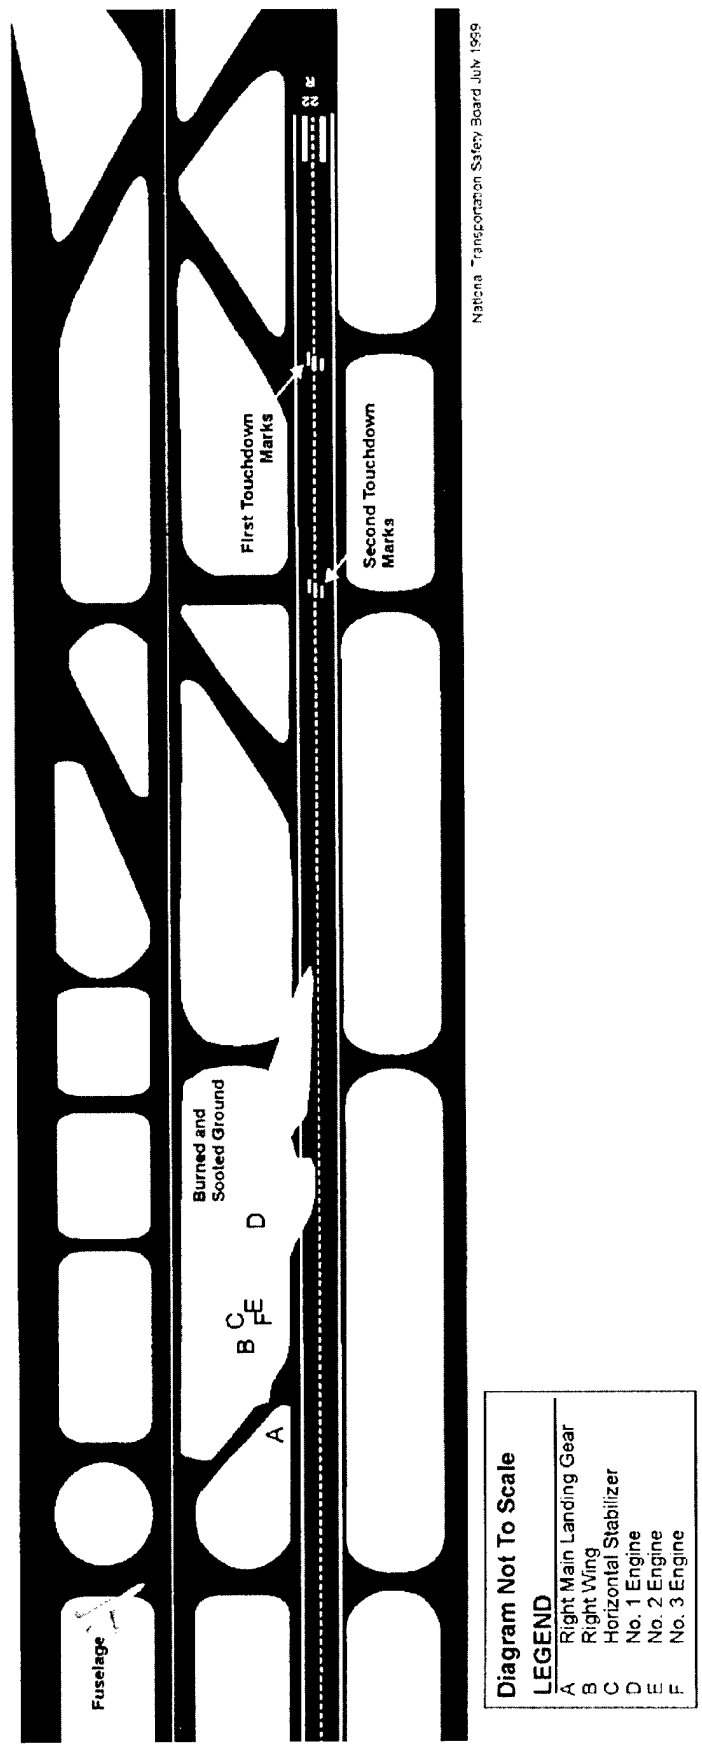
Figure 7. Wreckage distribution diagram.

The airplane's wreckage was distributed along a 2,900-foot-long debris path that gradually arced to the right across runway 22R (see figure 7). Pieces of the right inboard trailing edge flap were found at the beginning of the wreckage path, about 2,226 feet from the runway's displaced threshold. The main wreckage, located about 5,126 feet from the runway threshold and 580 feet to the right of the runway centerline, comprised the fuselage, left wing, nose gear, left MLG, center MLG, and horizontal stabilizer. The fuselage came to rest inverted with the nose on a 95° heading. Other airplane components and structure separated from the airplane during the crash sequence and were located along the debris path.

Rubber marks consistent with the touchdown of the airplane's right MLG tires were found about 1,126 feet from the runway displaced threshold. Rubber marks consistent with the touchdown of the left MLG tires and center MLG tires were found at 1,151 feet and 1,160 feet from the runway displaced threshold, respectively. The location of the tire marks was consistent with a touchdown near the center of the runway. Rubber marks consistent with a second touchdown of the right MLG tires were found about 1,924 feet from the runway displaced threshold (798 feet after the tire marks consistent with the first touchdown). Rubber marks consistent with the center MLG tires were found again about 1,983 feet from the runway displaced threshold. The locations of the second touchdown tire marks were consistent with a touchdown near the center of the runway. The right MLG tire rubber marks veer to the right about 1,995 feet from the runway displaced threshold.

Ground scarring consistent with the No. 3 (right) engine nacelle contacting the runway were found about 2,164 feet from the runway displaced threshold and continued to about 3,476 feet from the runway threshold. Runway scarring consistent with impact of the right inboard trailing edge flap was found about 2,299 feet from the runway threshold, ending about 2,376 feet from the threshold (where the right inboard trailing edge flap was found). Soot marks consistent with burning fuel were found about 2,506 feet from the threshold and continued to the end of the wreckage path. Runway scrape marks and purple paint⁴² consistent with the airplane's tail striking the runway were found about 2,644 feet from the runway threshold and ended about 3,060 feet from the threshold. About 2,826 feet from the threshold, runway scrapes, soot marks, and runway surface gouging began turning toward the right of the runway.

The right wing, the vertical stabilizer, and all three engines separated from the airplane and were found in a grassy area to the right of the runway, about 4,577 feet from the runway threshold, and had sustained fire damage consistent with a postaccident fuel fire. The right MLG strut assembly and two MLG wheels and tires were found on the right edge of the runway, about 4,805 feet from the runway threshold. The other two right MLG wheels and tires were found about 235 feet to the right of the runway centerline and about 4,957 feet from the threshold.
